New York State Department of Transportation

PIA Safety Flag NB23U4W002

BIN: 1065318

Feature Crossed: 6TH AVENUE

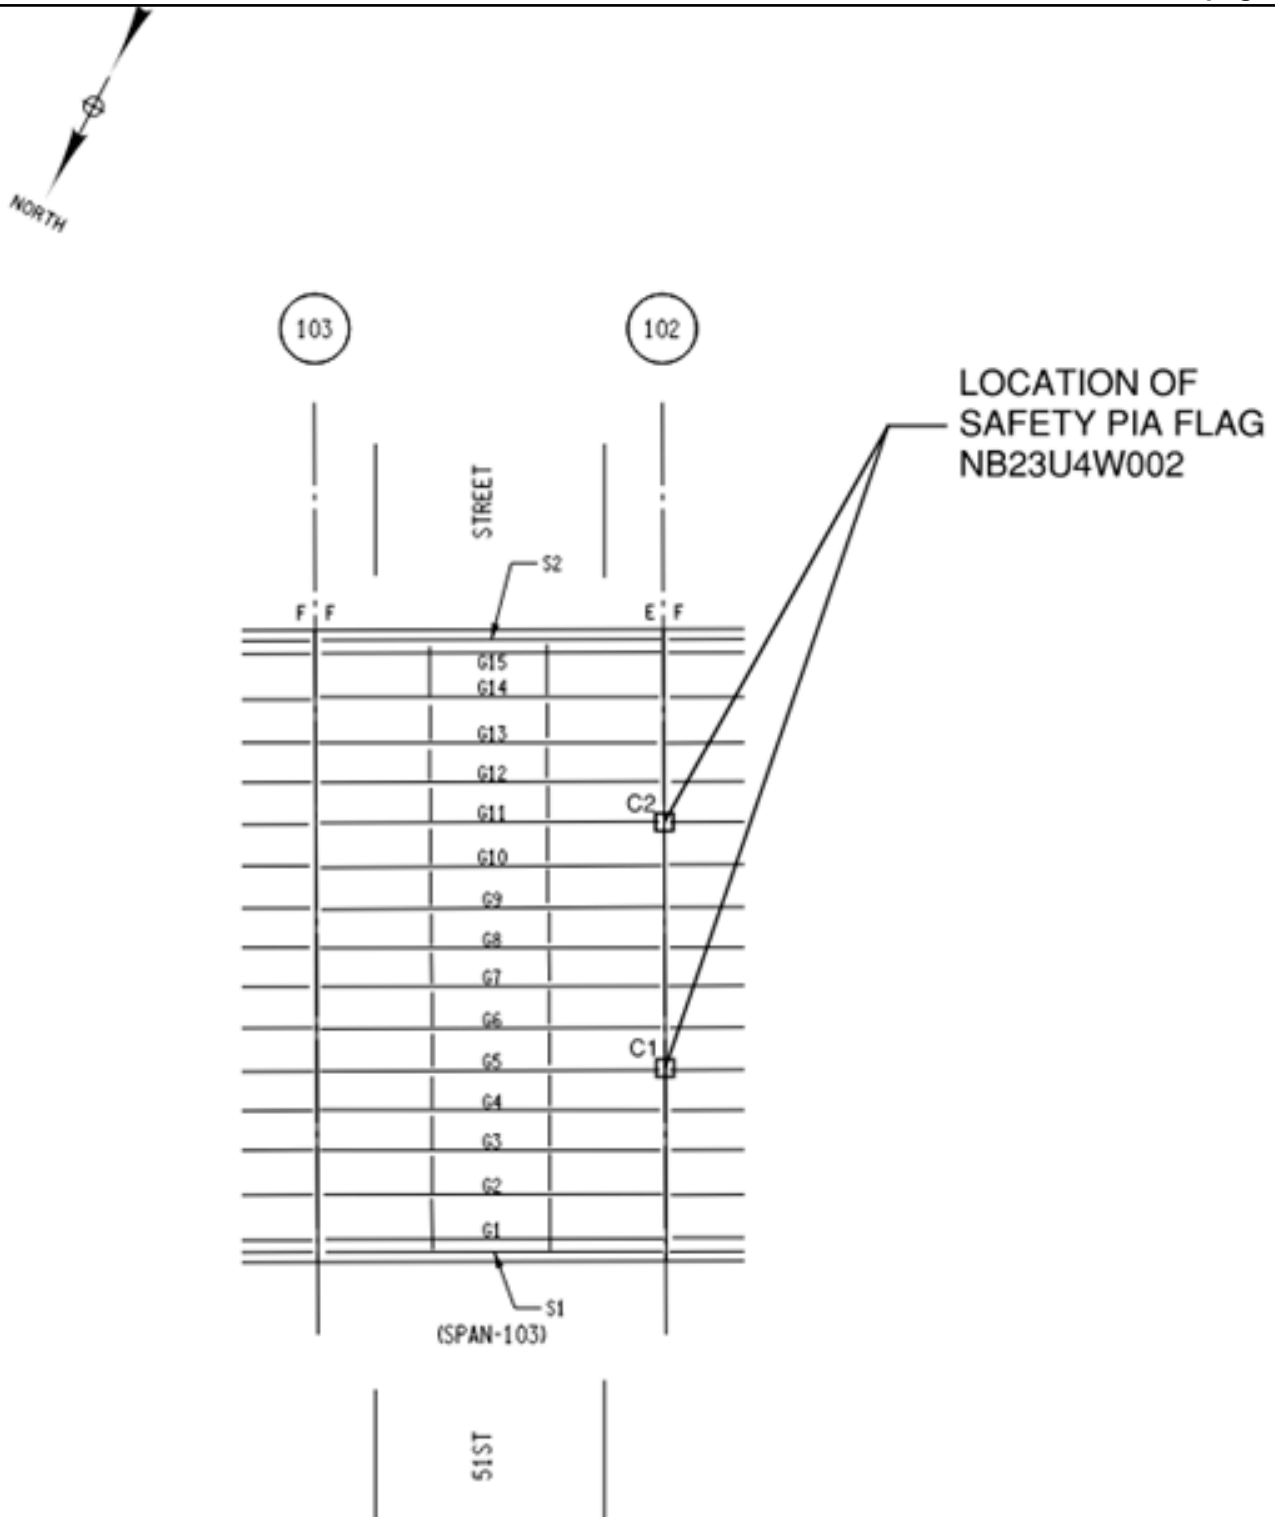
Photo Number: 1

Location: Span 103, Pier 102, Column C1 end face and Column C2 end face (51st street and 3rd avenue intersection)

**Attachment Description: Safety PIA Flag Location**

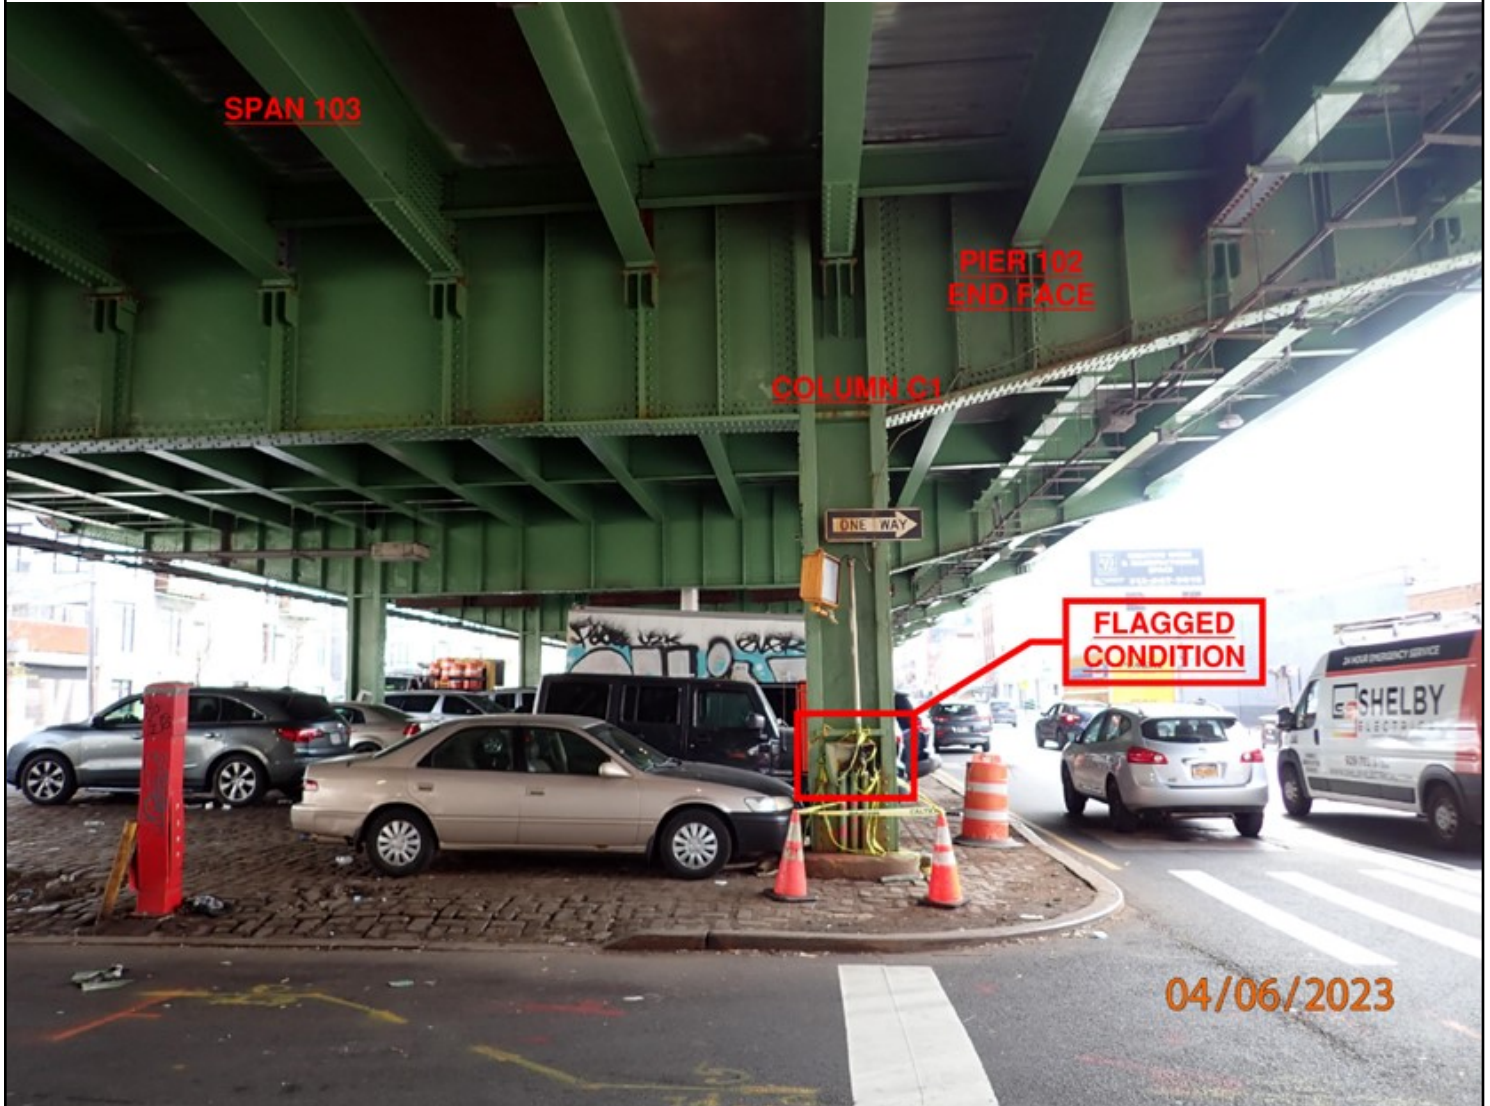
Photo Number: 2

Attachment Description: General view of the flagged condition under Span 103, Column C1 at Pier 102. Looking Begin.

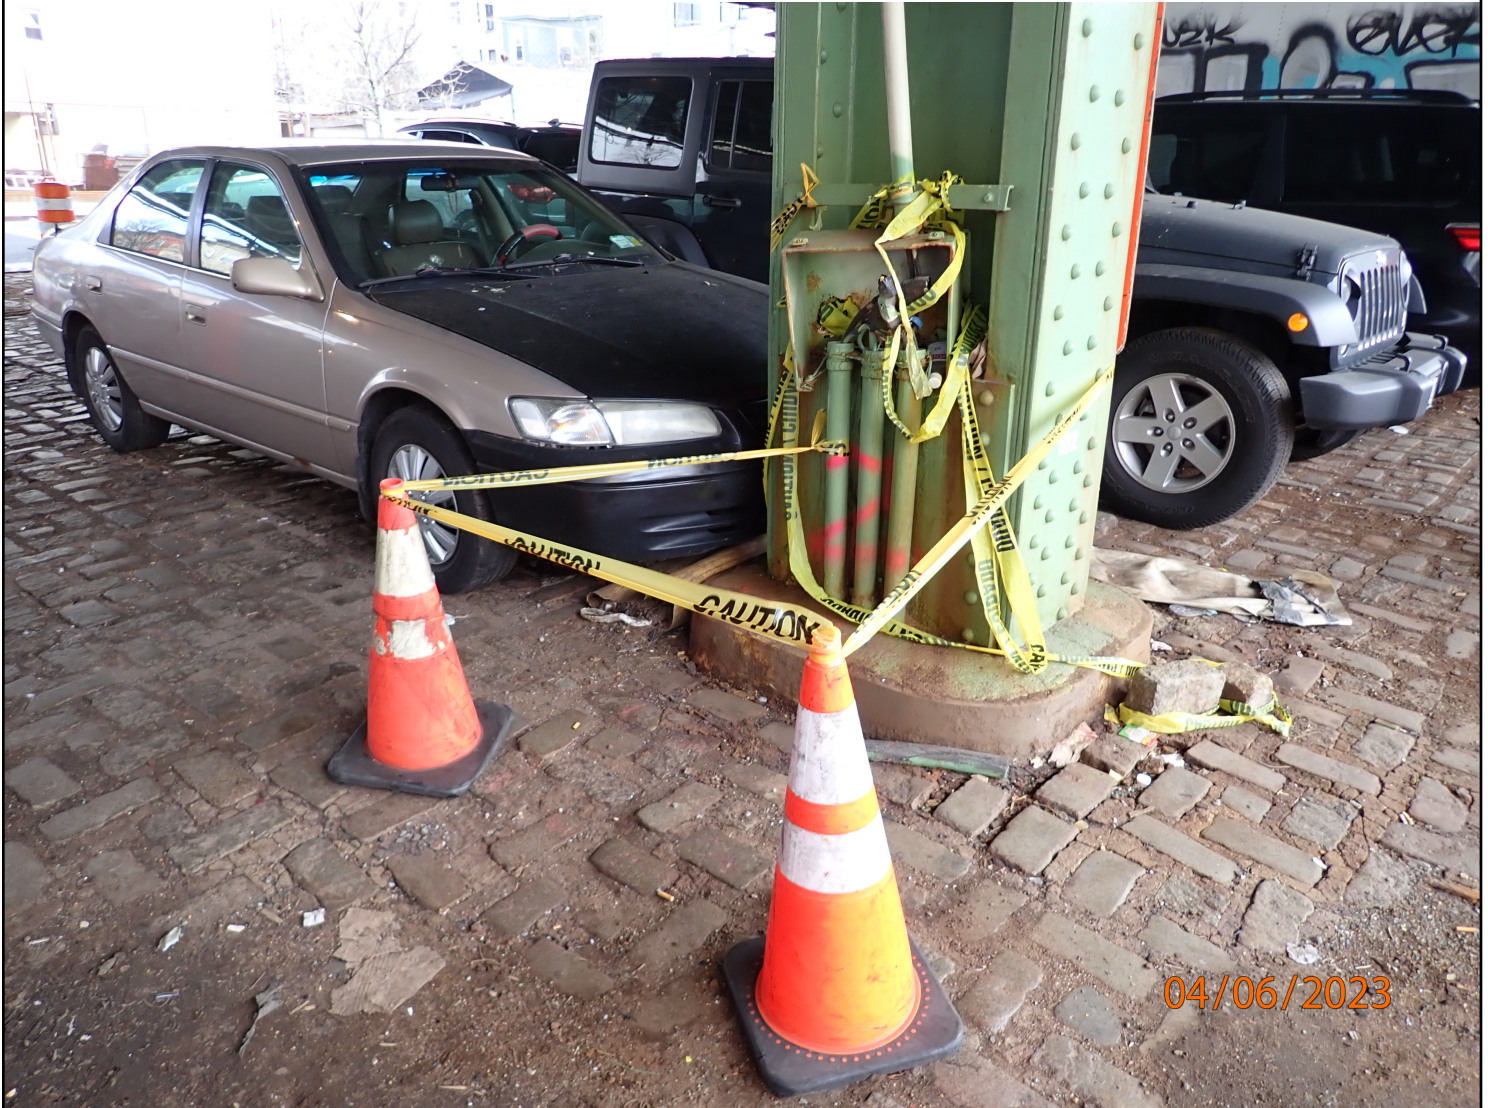
Photo Number: 3

Description: The junction box for the traffic light and attached to Column C1 is broken with exposed electric wires. This location is located at 3' above the ground on the sidewalk and can be accessed by walking. The area is temporarily secured with cones and caution tape. In a similar manner, the cover to the junction box attached to Column C2 is loose, but no wires are currently exposed.

Attachment Description: The sidewalk at the end face of Column C1 of Pier 102 under Span 103. The electrical junction box is broken with exposed wires. The area has been coned off with yellow caution tape. Looking Begin-Right.

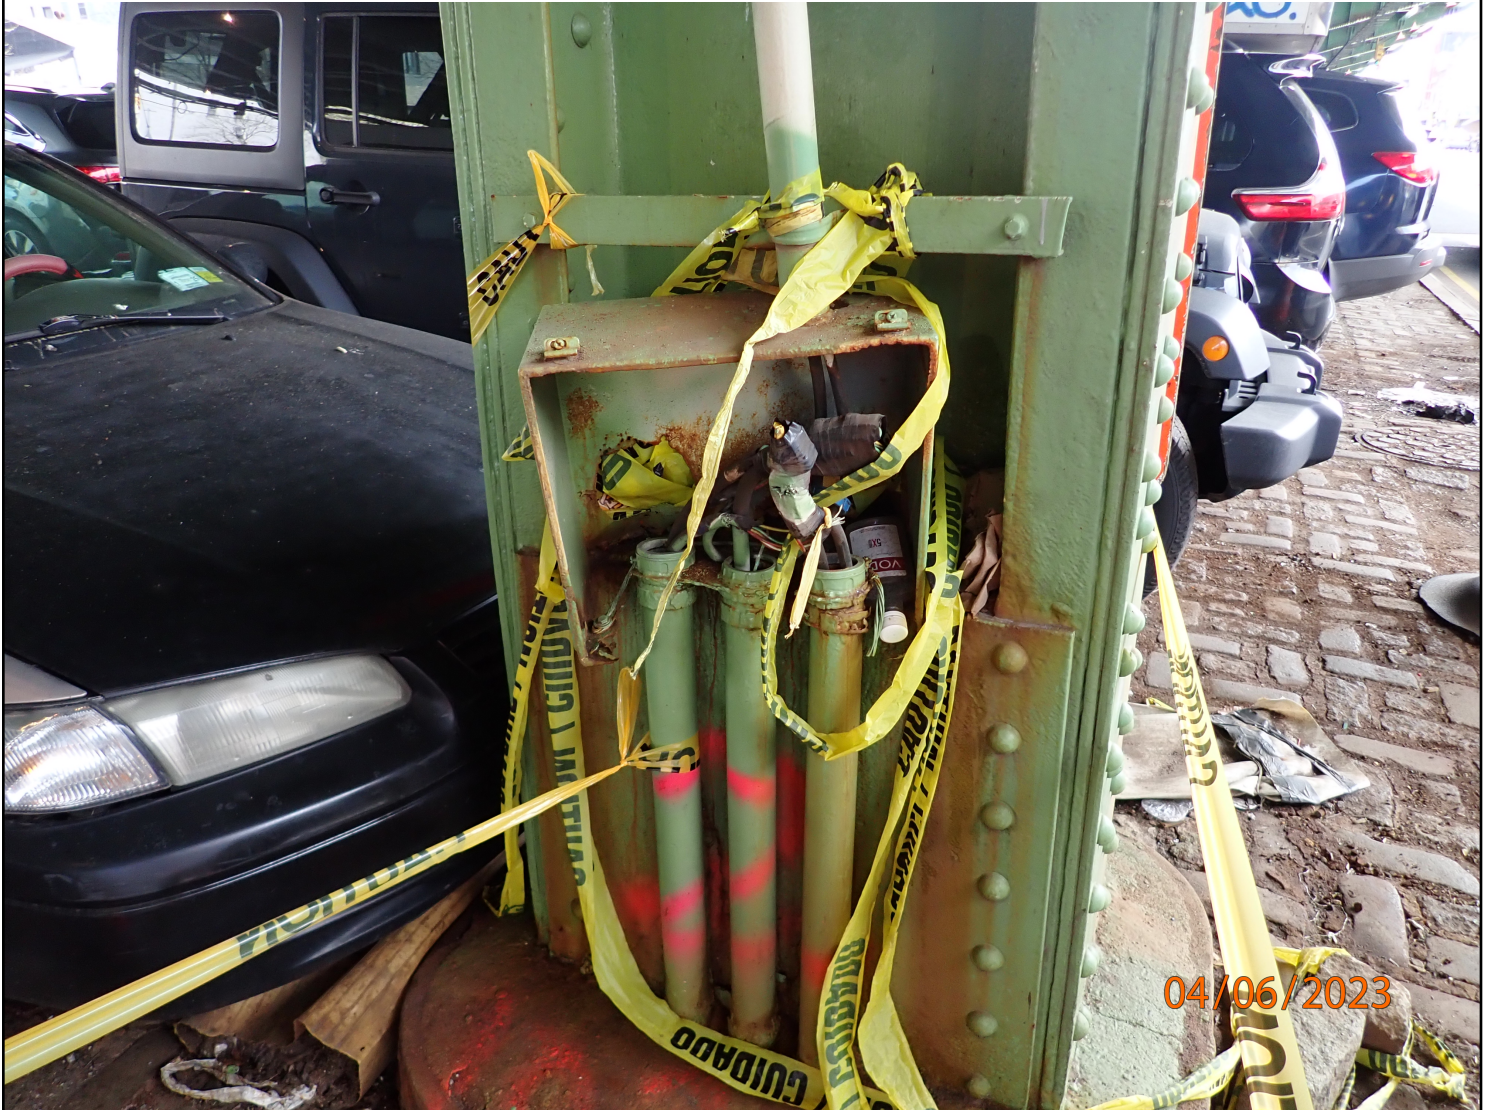
Photo Number: 4

Attachment Description: The close up view of broken electrical junction box with exposed wires at Column C1, Pier 102, Span 103. Looking Begin.

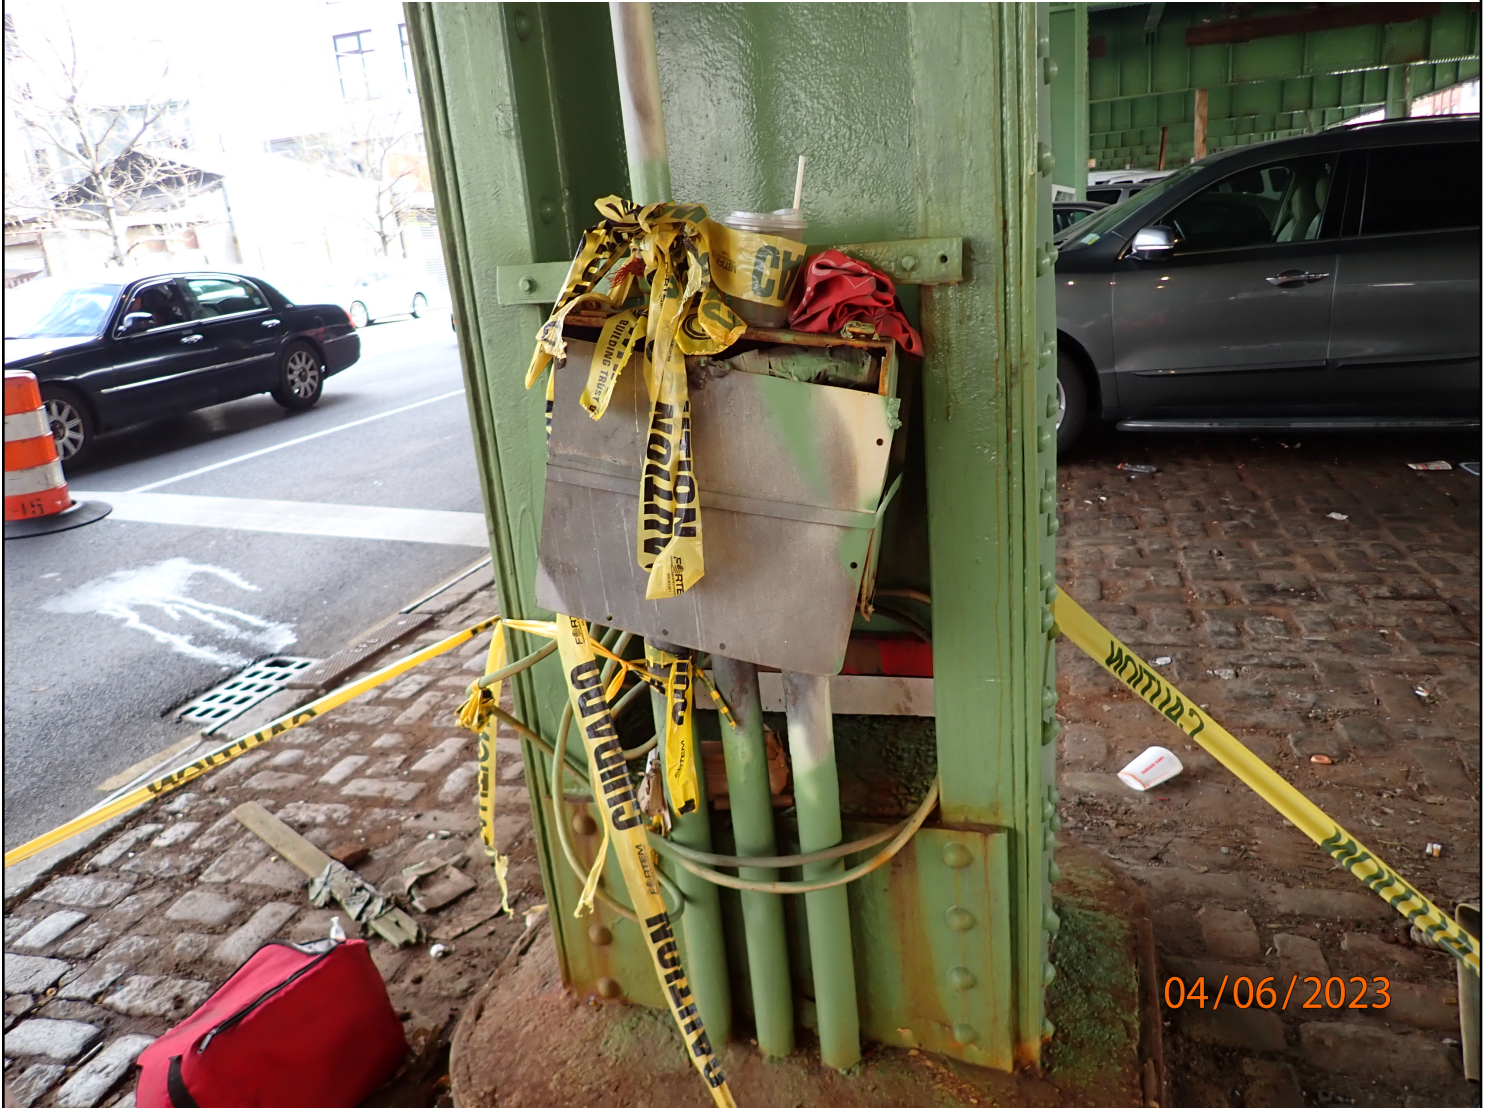
Photo Number: 5

Attachment Description: The close up view of electrical junction box with loose cover at Column C2, Pier 102, Span 103. Looking Begin-Right.
